DEPARTMENT OF TRANSPORTATION**DIVISION OF ENGINEERING SERVICES**

Contract #: 04-0120F4Cty: SF/ALA Rte: 80 PM: 13.2/13.9File #: 69.28**WELDING INSPECTION REPORT****Resident Engineer:**Pursell, Gary**Address:** 333 Burma Road**City:** Oakland, CA 94607**Report No:** WIR-001256**Date Inspected:** 13-Jan-2008**Project Name:** SAS Superstructure**OSM Arrival Time:** 1400**Prime Contractor:** American Bridge/Fluor Enterprises, a JV**OSM Departure Time:** 2330**Contractor:** Zhenhua Port Machinery Company, Ltd (ZPMC), Changxing Island **Location:** Shanghai, China**CWI Name:** Zhu Zhong Hai, Fu Yu Hong**CWI Present:** Yes No**Inspected CWI report:** Yes No N/A**Rod Oven in Use:** Yes No N/A**Electrode to specification:** Yes No N/A**Weld Procedures Followed:** Yes No N/A**Qualified Welders:** Yes No N/A**Verified Joint Fit-up:** Yes No N/A**Approved Drawings:** Yes No N/A**Approved WPS:** Yes No N/A**Delayed / Cancelled:** Yes No N/A**Bridge No:** 34-0006**Component:** Tower mock ups and OBG components**Summary of Items Observed:**

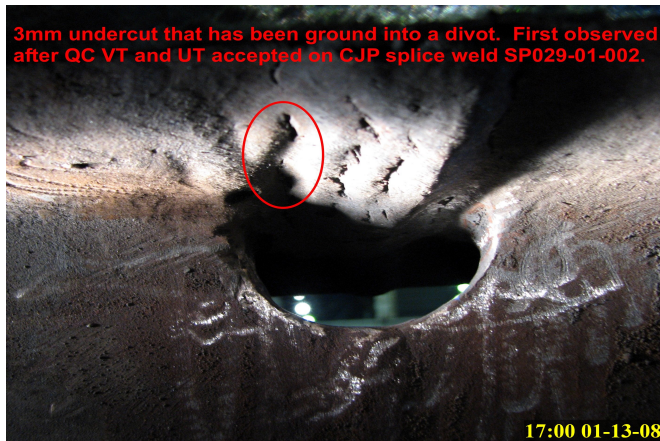
The QA inspector was informed that the welders were Li Zhou Qian, Xin Meng and Li Shu Liang. The QA inspector observed that joints being welded were 014, 015, 018, 019, 022 and 023. During the welding, the QA inspector noted that the welding parameters are being measured and recorded by Guo Yang Wei, who was observed and reported on the TL-6031 from 1-4-2008. The QA inspector noted that this person is not an approved CWI or CAWI. The QA inspector asked him if there was a CWI and was directed to a person on the ground who appeared to be watching the welding and preheat temperature. The QA inspector then asked this person if he was the CWI and the QA inspector was informed that he was. The QA inspector recognized this person and on 1-6-2008 the QA inspector had identified that Hu Wei Qing is not an approved CWI or CAWI. The QA inspector again asked him if he was the CWI, to which Hu Wei Qing replied that he was. The QA inspector then continued to make random observations of the work in progress and noted that one of the T-stiffeners had been previously identified as visually non-conforming to AWS D1.5 2002, section 6.26.1.5. The QA inspector was unaware of repairs being completed and observed that, as reported on 1-2-2008 as 3mm deep undercut, there was now a large divot that apparently resulted in grinding of the undercut. The QA inspector noted that a small portion of the undercut is still visible in the bottom of the grinding divot. The QA inspector informed the Quality Control Liaison (QCL) Fu Yu Hong of this observation and of the previous observations of the complete joint penetration (CJP) T-stiffener splice weld #SP029-01-002. The QCL was shown the weld and undercut/grinding divot. The QCL verified the undercut/grinding depth and then contacted the CWI Xu Xian Ping. At the end of shift, the QA inspector did not observe any further work or repairs at this location. The QA inspector also noted that on 1-3-2008, there appears to have been an acceptable ultrasonic test that was conducted by a ZPMC technician. See the attached photo.

The conversations were generally regarding the observed work in progress and are described above. The QA inspector also had a conversation with the QCL Fu Yu Hong regarding the observed undercut/grinding divot on SP029-01-002. The QA inspector was familiar with it's previous condition and explained to the QCL what appeared to have been done since the last observations made by the QA inspector. The QCL seemed concerned and he immediately informed other ZPMC personnel of the apparent condition. The QA inspector was informed that CWI Xu Xian Ping was informed, the QA inspector observed this CWI examining the part but was not informed of any planned work to repair this condition.
